## 17.0 Slick Rock, Colorado, Disposal Site

### 17.1 Compliance Summary

Figure 17–1. 2003 Annual Compliance Drawing for the Slick Rock, Colorado, Disposal Site

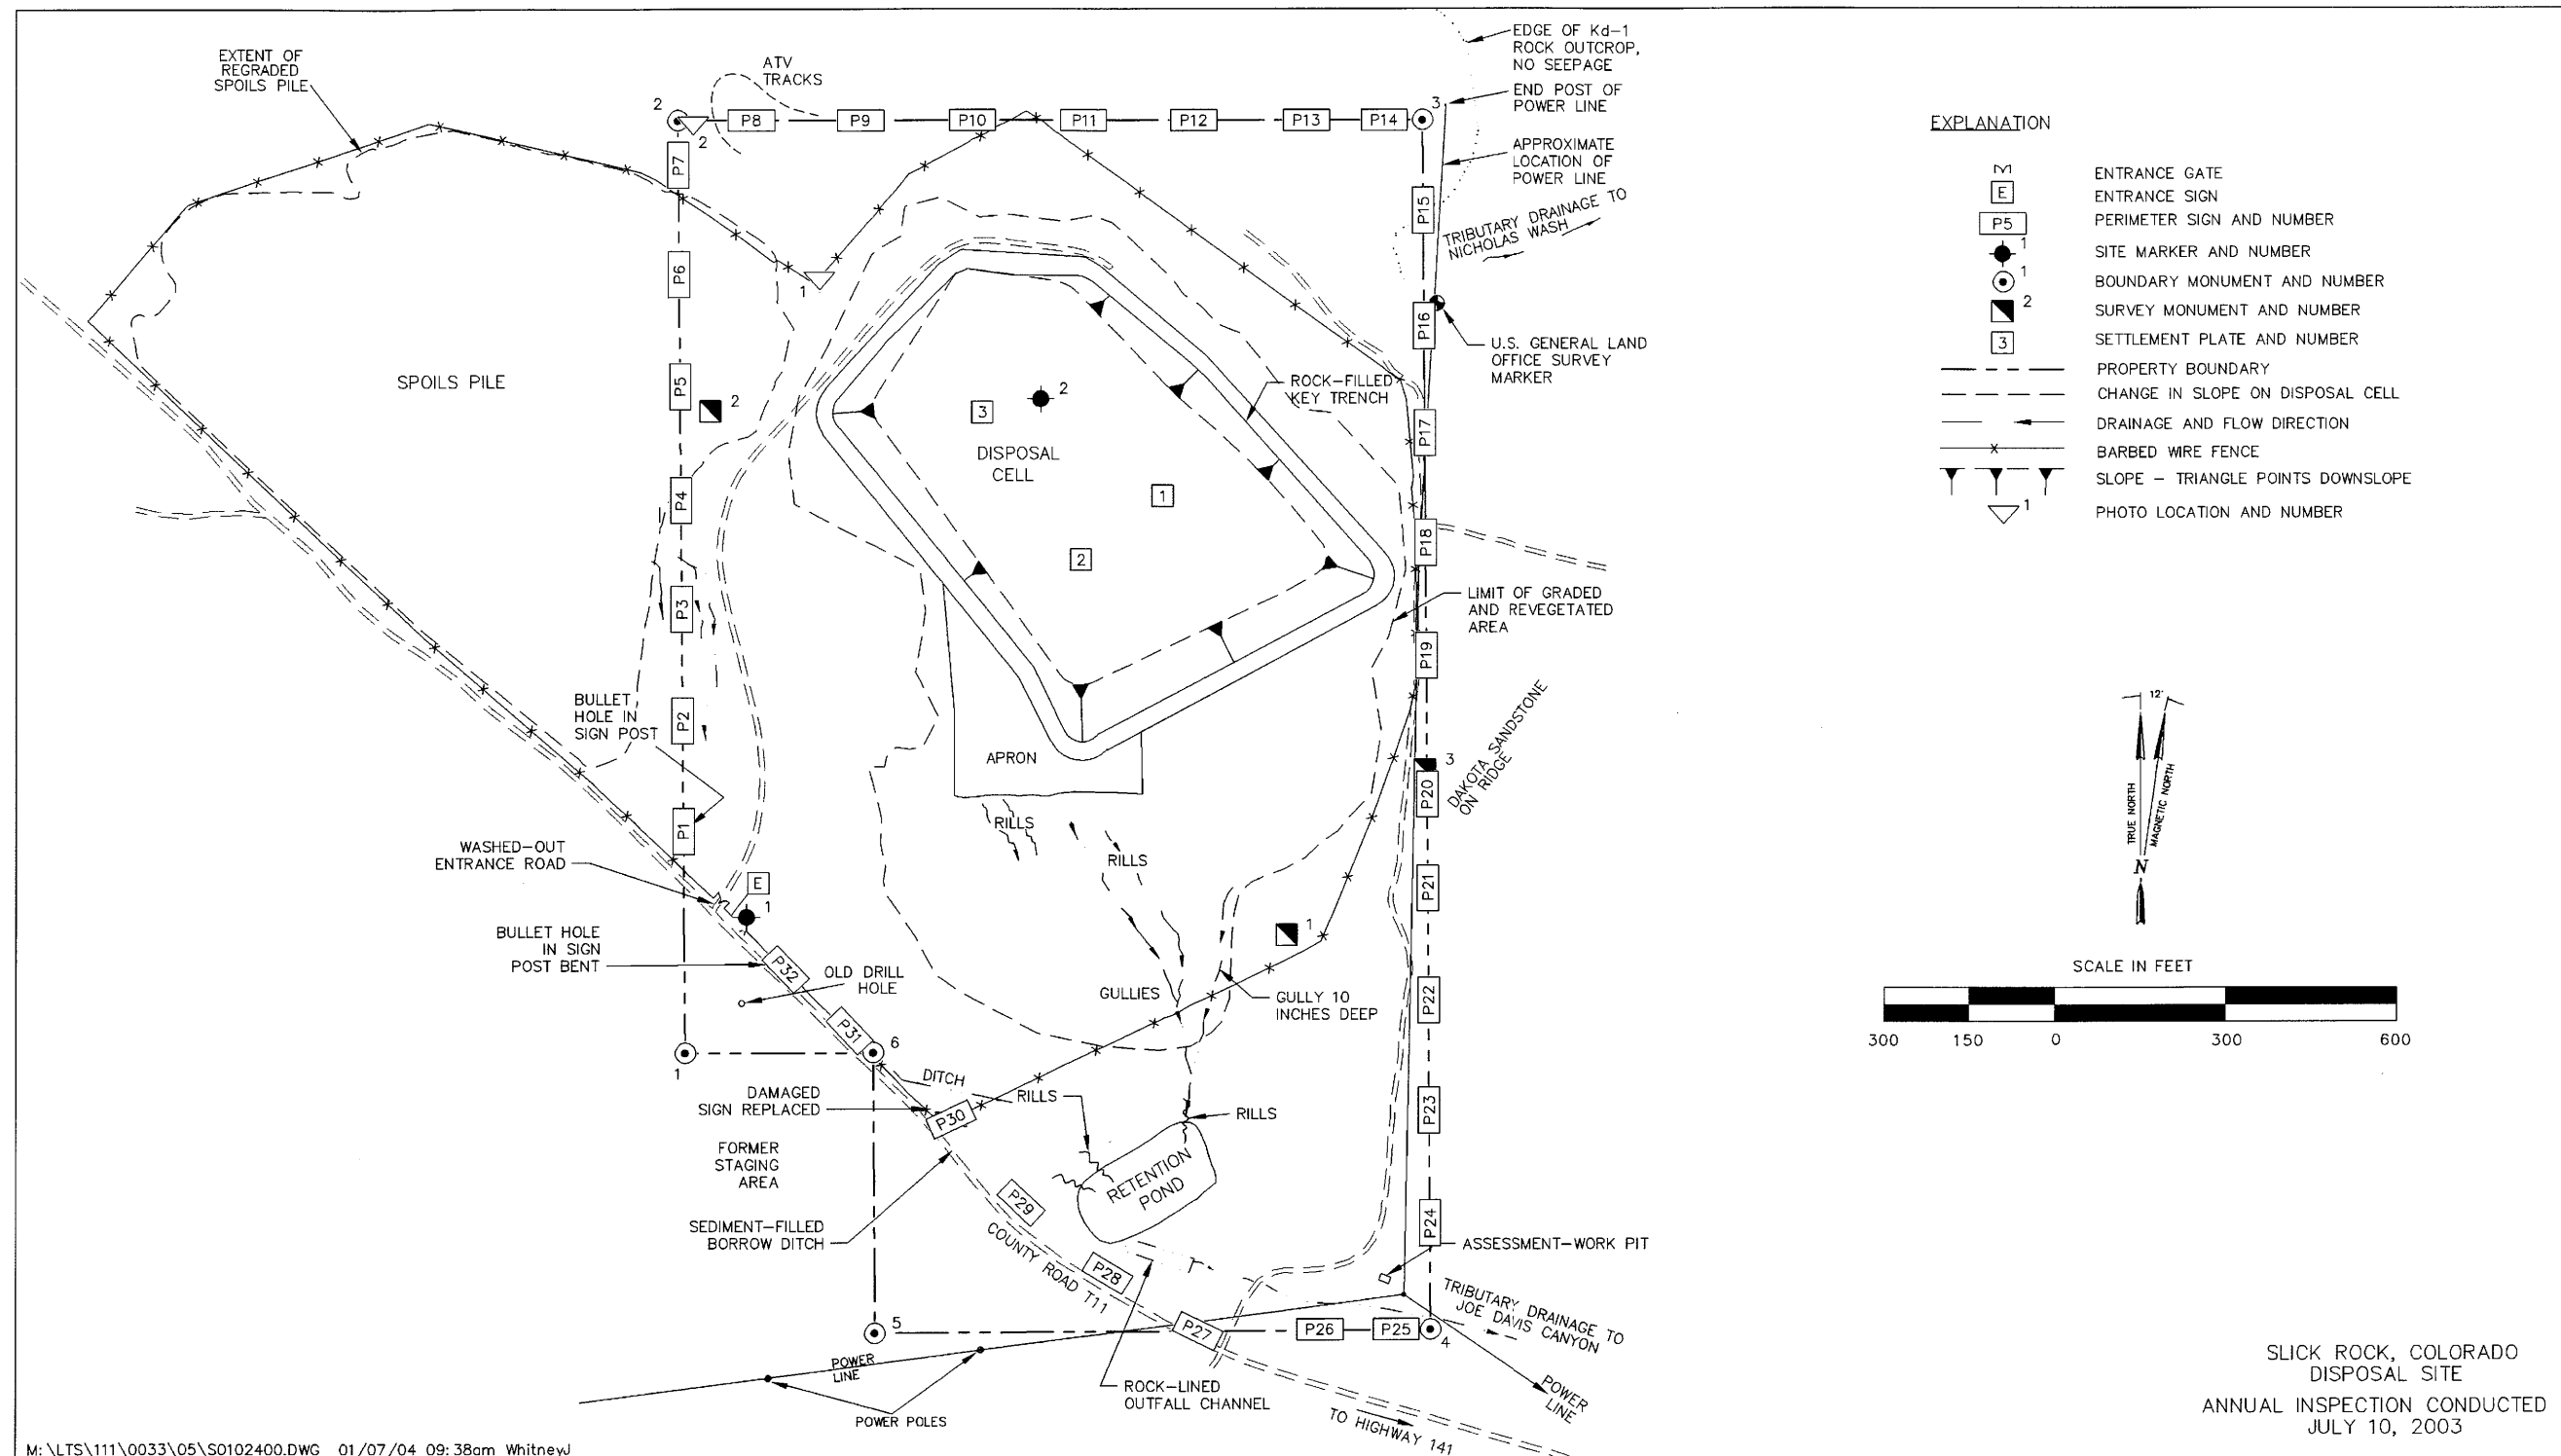
The site, northeast of Slick Rock, Colorado, was inspected on July 10, 2003. Results of the inspection are described below. Features and photograph locations (PLs) mentioned in this report are shown on Figure 17-1. Numbers in the left margin of this report refer to items summarized in the Executive Summary table.

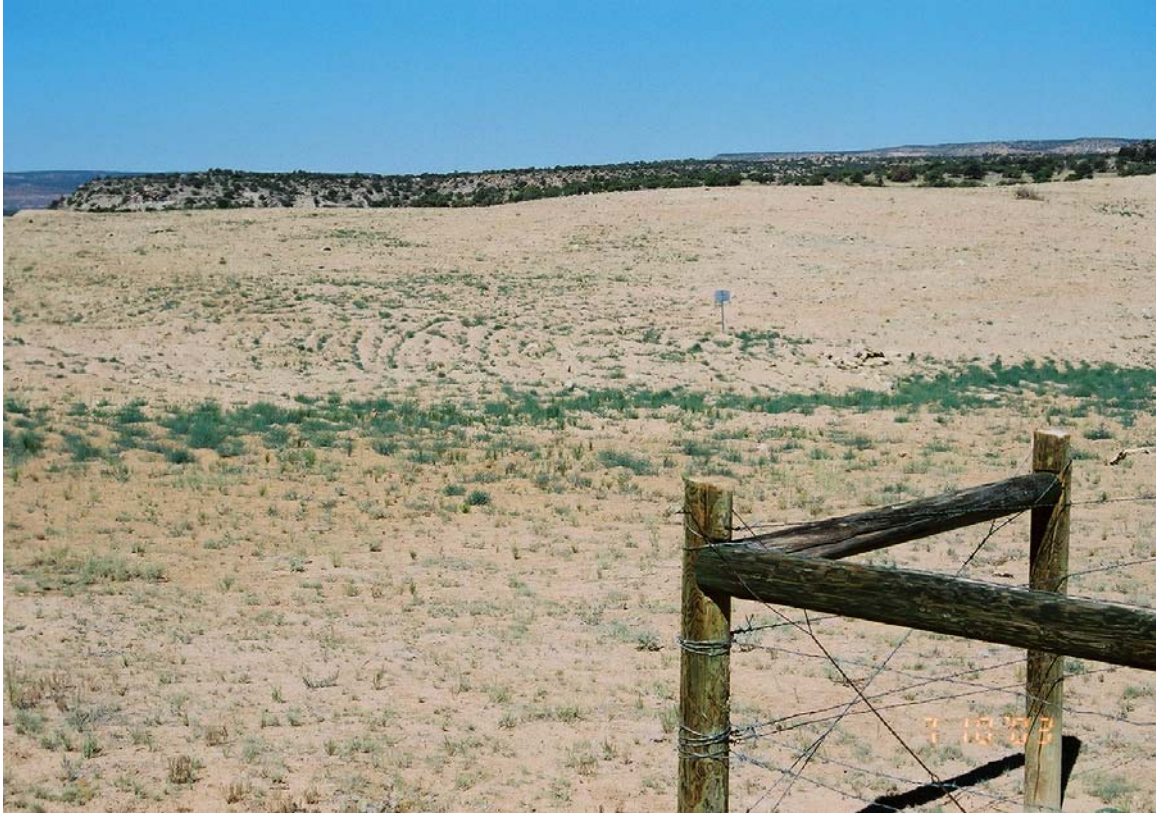
In September 2001, DOE regraded the slopes of the spoils pile to reduce and reshape them to more natural contours to reduce erosion, and seeded the slopes. No significant erosional features have developed in the spoils pile area. DOE also ripped and reseeded the surface of the former staging area. Due to continued drought conditions in the region, the vegetative cover had not significantly improved over the previous year and continues to be very sparse in both areas (PL-1).

*SRK 7/2003. PL-1. Sparse vegetation on the northeast slope of the regraded spoils pile.*

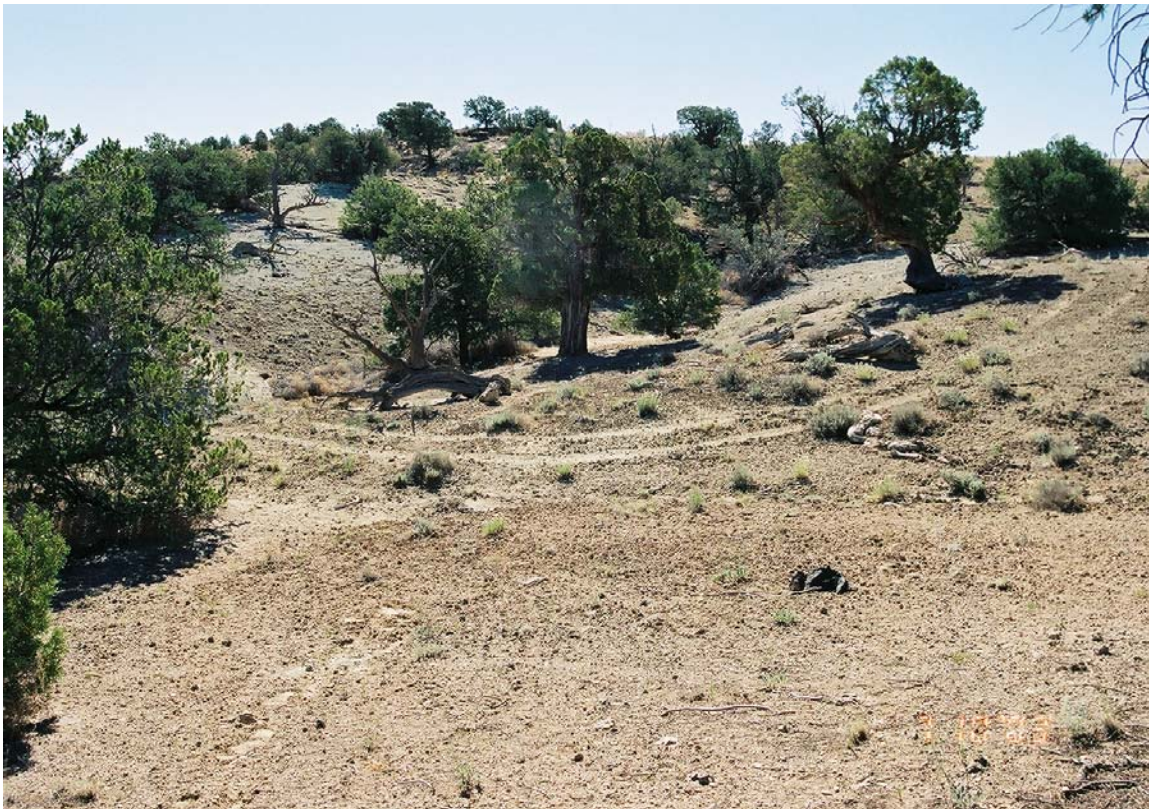
The natural, undisturbed areas outside the disposal site support grass and scattered piñon and juniper trees. The primary land use is grazing. Steep hillsides north and northeast of the site slope eastward into Nicholas Wash. Areas north and northeast of the site are routinely used for recreational purposes (e.g., hunting, four-wheeling, firewood cutting, etc.). Tracks from an all-terrain vehicle were observed on the northwest corner of the property (PL-2). Although perimeter signs are clearly visible in this area, this portion of the DOE site is uncontrolled (i.e., not fenced) and is susceptible to trespass. No other disturbances in the outlying areas were noted.

*SRK 7/2003. PL-2. All-terrain vehicle tracks in the northwest corner of the property.*
